TECHNICAL MEMORANDUM

SUBJECT: February 1, 2017 – Field Observations

DATE: February 3, 2017

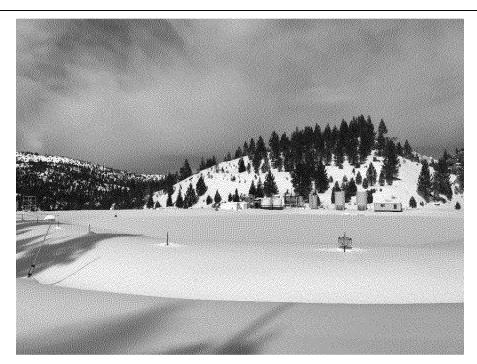
Photograph 1: Pond 1

The pond water (snow) levels in Pond 1, Pond 2S, Pond 2N, Pond 3, and Pond 4 were all below the overflow structures as seen in the Photographs 1 through 5.

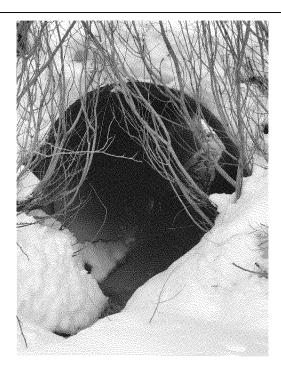
Field observations of the Leviathan Creek culvert downstream of the beaver dam / beaver pond complex were conducted to determine if there was indication of beaver dam failure. Field staff did not observe any debris restricting flow or any indication of beaver dam failure as seen in Photographs 6 and 7.

Photograph 6: Leviathan Creek Culvert Looking Downstream

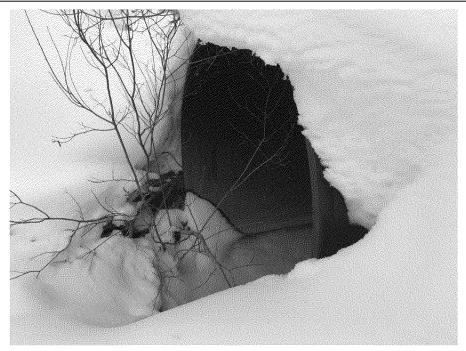
Photograph 7: Leviathan Creek Culvert Looking Upstream
